TARGETED BROWNFIELD ASSESSMENT

ELK CITY ARMORY

ASTM E 1527-05 Phase I Environmental Site Assessment All Appropriate Inquiry

Oklahoma Department of Environmental Quality
Land Protection Division
707 N. Robinson
P.O. Box 1677
Oklahoma City, Oklahoma 73101-1677

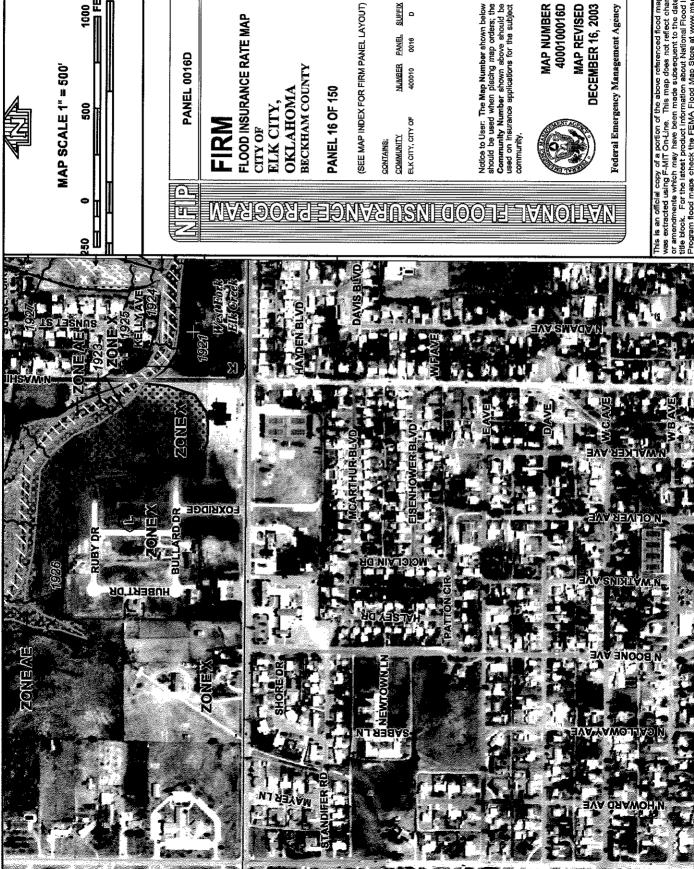
Appendix C Flood Insurance Rate Map

PANEL 0016D

MAP NUMBER 4000100016D MAP REVISED Federal Emergency Management Agency **DECEMBER 16, 2003**
